Landslides and related features interpreted
from aerial photographs:
1:60,000 (black and white) 1959
1:80,000 (black and white) 1977

LANDSLIDES AND RELATED FEATURES

OF THE LANDSAW, KY., QUADRANGLE
by
William F. Outerbridge
1982
U. S. Geological Survey
OPEN FILE MAP 82-51 (F-5)

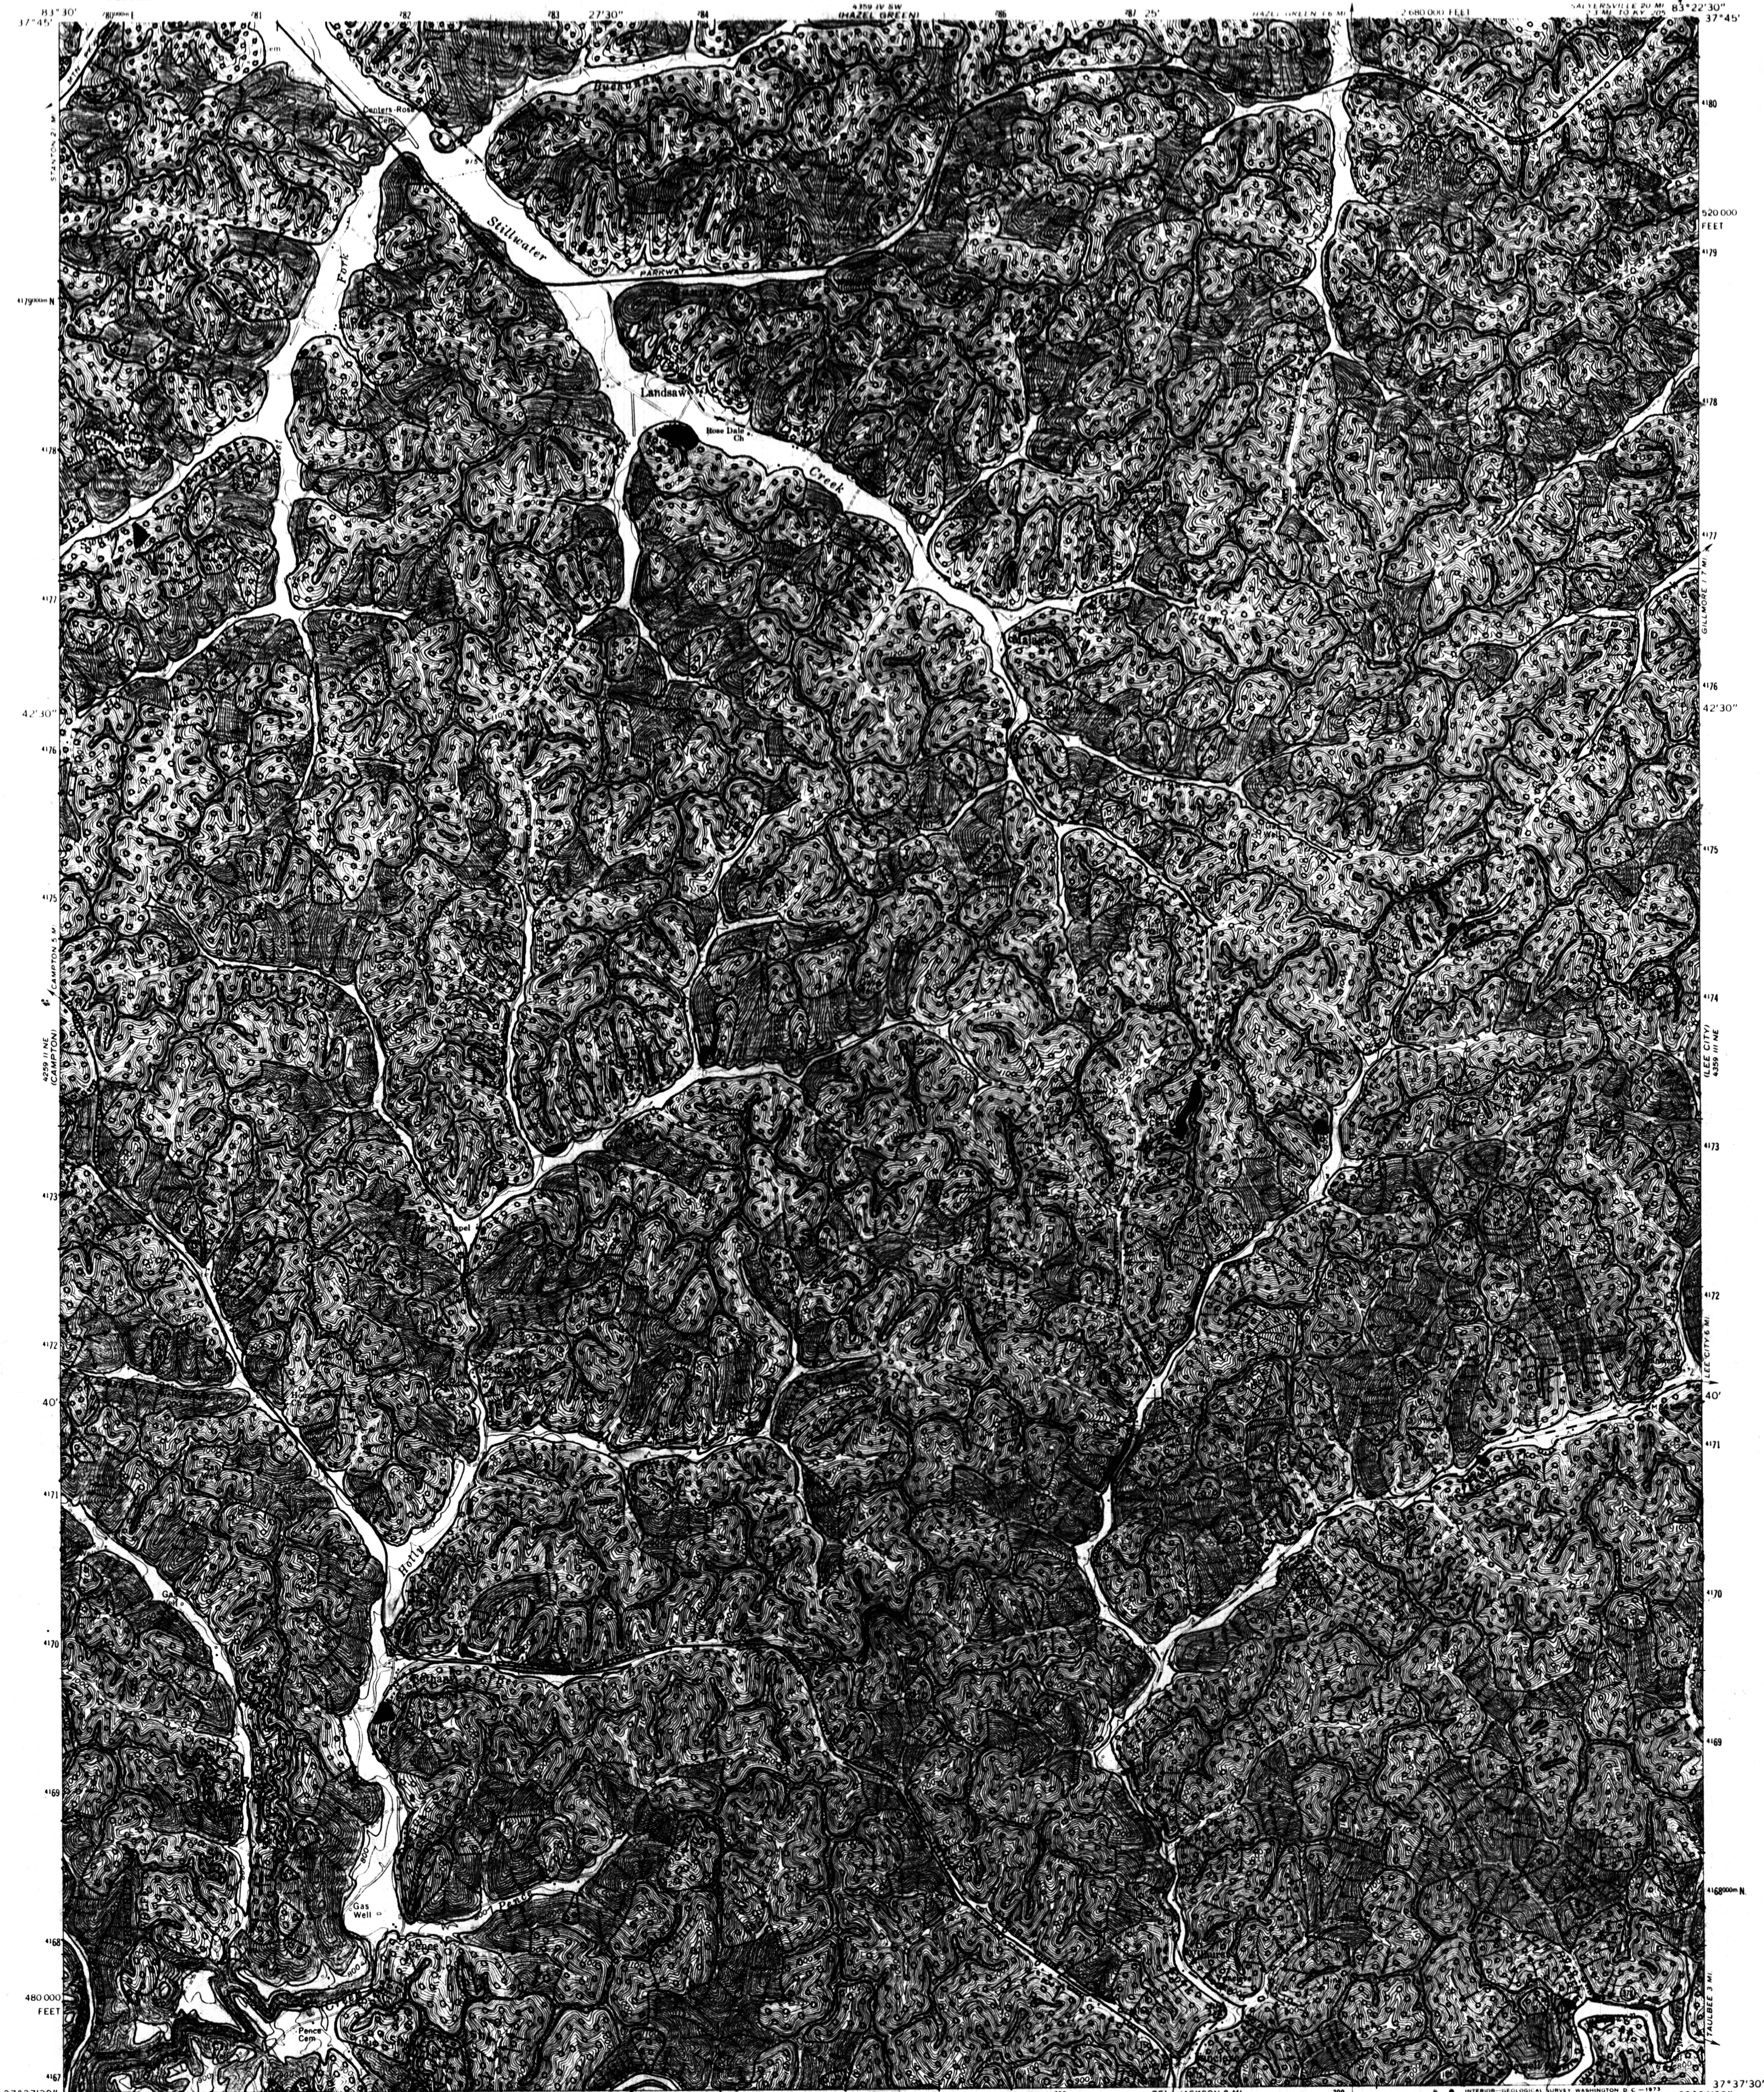
Photointerpretation and field check 1978,⁹
This report is preliminary and has not
been reviewed for conformity with U. S.
Geological Survey editorial standards.
Data on location of strip mines in part from:
Hansen, Wallace R. and Johnston, John E., 1963,
Geology of the Landsaw quadrangle, Kentucky:
U. S. Geological Survey Geologic Quadrangle Map
GQ-201, scale 1:24,000.

**ACTIVE OR RECENTLY ACTIVE LANDSLIDE**
Complex landslide composed of earthflow, debris
slide, earth and rock slump. Identified from
historical records, and from scars, debris and
other field evidence. Ground extremely unstable;
sliding accelerated by excavation, loading and
changes in drainage conditions. May include
areas with several active slides too small to
be shown separately. Questioned where doubtful.

**OLD LANDSLIDE**
Area of extensive hummocky ground caused by
earthflow and earth and rock slump. Lacks
clear evidence of active sliding. Relatively
stable in natural, undisturbed state,
generally not affected by small structures properly
sited in areas away from the edge of the toe;
can be reactivated by extensive, rapid exca-
vation, loading, and changes in ground water and
surface water conditions. Area of old landslide
probably includes recent ones not identified
from field evidence or otherwise documented.
Upslope boundary of landslide generally defined
by modified scarp, but downslope (toe) may be
gradational and not well defined. Questioned
where doubtful.

**COMBINATION LANDSLIDE**
Area of recent and old slides in which
individual slides are not identified.

**COLLUVIAL SLOPE**
Valley wall along major streams with slope as
steep as 40° (85%); stony, clayey silt soil up
to 50 ft. (15 m) thick; commonly buttressed by
a terrace or bench at the toe of the slope; very
susceptible to sliding by cutting of toe area,
removal of terrace or bench, and overloading;
slide commonly activated without apparent cause.

**COLLUVIAL SLOPES WITH LANDSLIDES**
Landslides too small or obscure to map
individually.

**AREAS SUSCEPTIBLE TO DEBRIS FLOWS AND DEBRIS
AVALANCHES**
Primarily shallow, narrow ravines and chutes with
accumulation of stony colluvium generally 10 ft.
(3 m) or less in thickness; susceptible to rapid
movement during intense rainfall. Most ravines
and chutes designated show evidence of former
debris flows and avalanches. Symbol & design-
ates historical debris flow or debris avalanche.

**AREAS SUSCEPTIBLE TO ROCKFALL**
Steep, locally vertical, natural and man-made
slopes and cliffs, 15 ft. (4.5 m) or more high;
formed dominantly of sandstone, limestone, sandy
shale, mudstone and claystone. Interbedded mud-
stone, claystone and shale weather rapidly leaving
sandstone and limestone rock faces unsupported.

**SOIL AND ROCK SUSCEPTIBLE TO LANDSLIDING**
Soil and rock similar to that involved in land-
slides elsewhere in map area; primarily areas
underlain by claystone, mudstone and shale
associated with other rock types. Rock weathers
rapidly on exposure forming clayey soil highly
susceptible to sliding. Includes coves (U-shaped,
shallow valleys) containing thick layers of clayey
soil that are very susceptible to sliding where
excavation breaks continuity of slope and where
overloaded by artificial fill.

AREAS LEAST PRONE TO LANDSLIDES
Map areas in which no patterns or symbols are shown;
primarily valley floors, ridge tops and broad
benches; modification by excavation and fill may
lead to local landslides.
